**Development of a CFRP System to Provide Continuity in Existing  
Reinforced Concrete Buildings Vulnerable to Progressive Collapse**

**Dissertation**

The University of Texas at Austin

**August 2007**

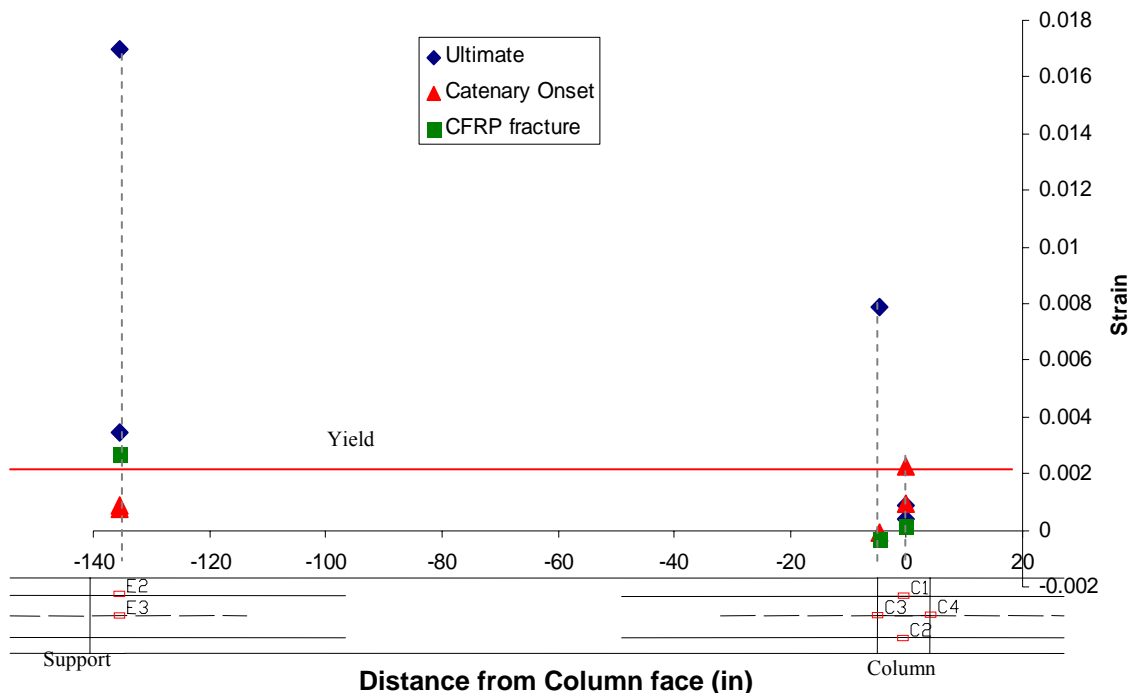
**Figure 5-35** Strains in negative moment reinforcement in PM-2

Strains in the negative moment reinforcement are shown in Figure 5-35. The strains in gages E2 and E3 were high due to the bending at support. The strains in gages near the column were high due to the tension from catenary action. Although not all gages recorded yield strains, the catenary tension force of 25 k is approaching the yield strength of the three negative moment reinforcing bars (32.1 k).

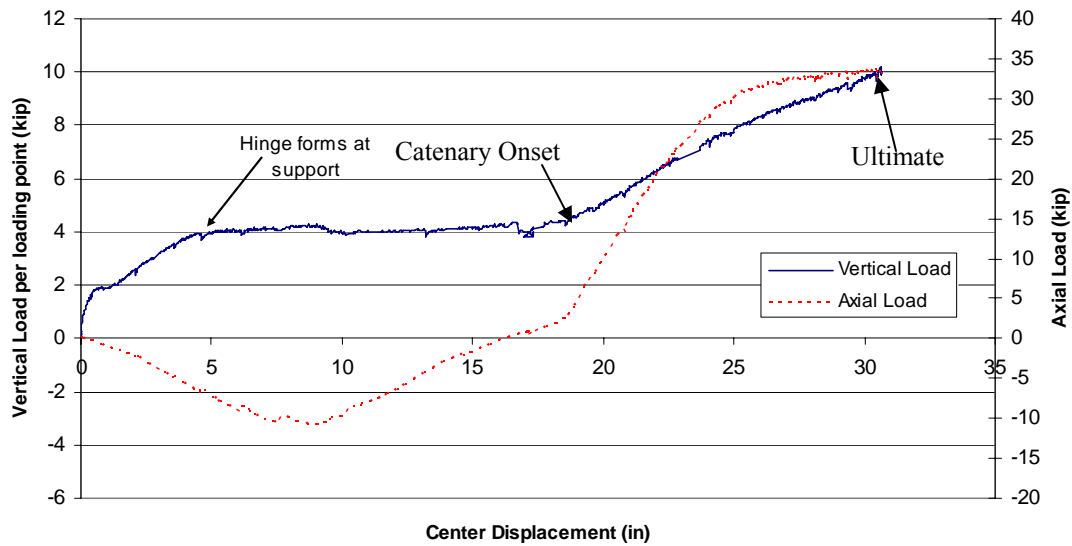
**Figure 5-37** Vertical and axial loads for NM-1

The specimen performed well and was able to reach the desired 10 k per loading point at 30.6 in. of displacement and 32.4 k of axial load, Figure 5-37 and Figure 5-38. At 32.4 k axial load, the threaded rod connecting the end of the specimen to the blue axial brace fractured, Figure 5-39.

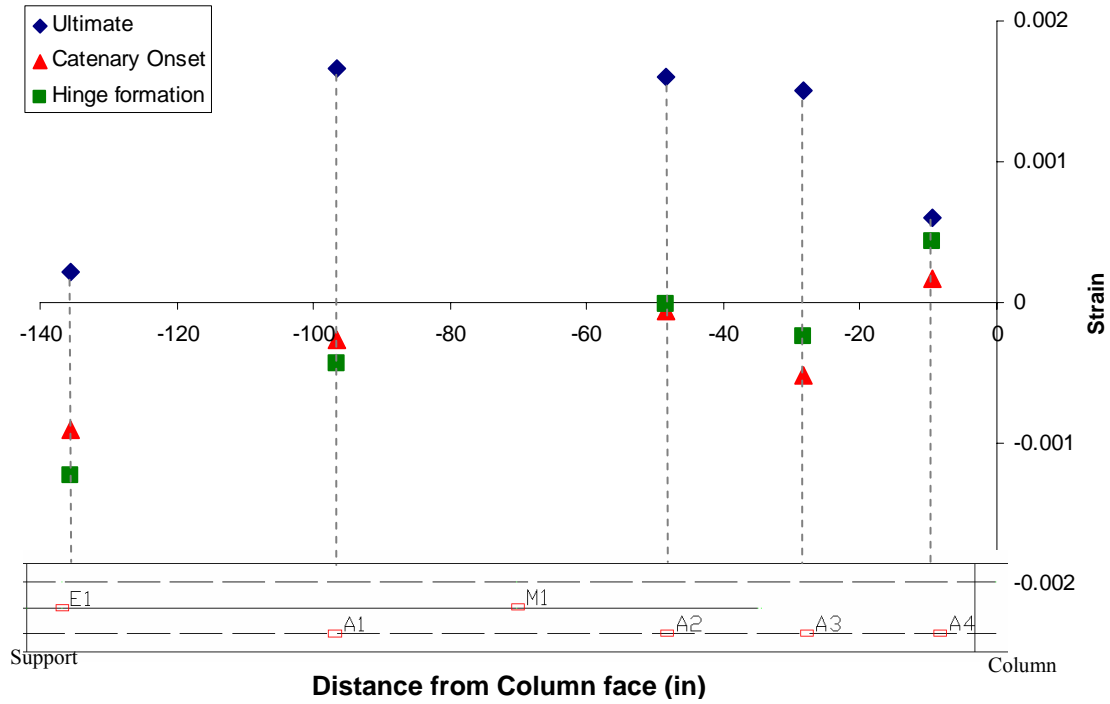
Figure 5-42 Strains in positive moment rebar for NM-1

The strains in the positive and negative moment reinforcement are shown in Figure 5-42 and Figure 5-43. At hinge formation, the strains in the negative moment rebar near the support were 0.0027 and 0.0032 with a strain of -0.0012 in the positive moment rebar at E1. These strains again indicate formation of a hinge near the support. At ultimate, strains throughout the positive moment rebar were nearing yield except near the discontinuity at the column line and the support as in specimen PM-2. The presence of significant yielding in the beam indicates that the stiffness of the beam will decrease as vertical load is increased.

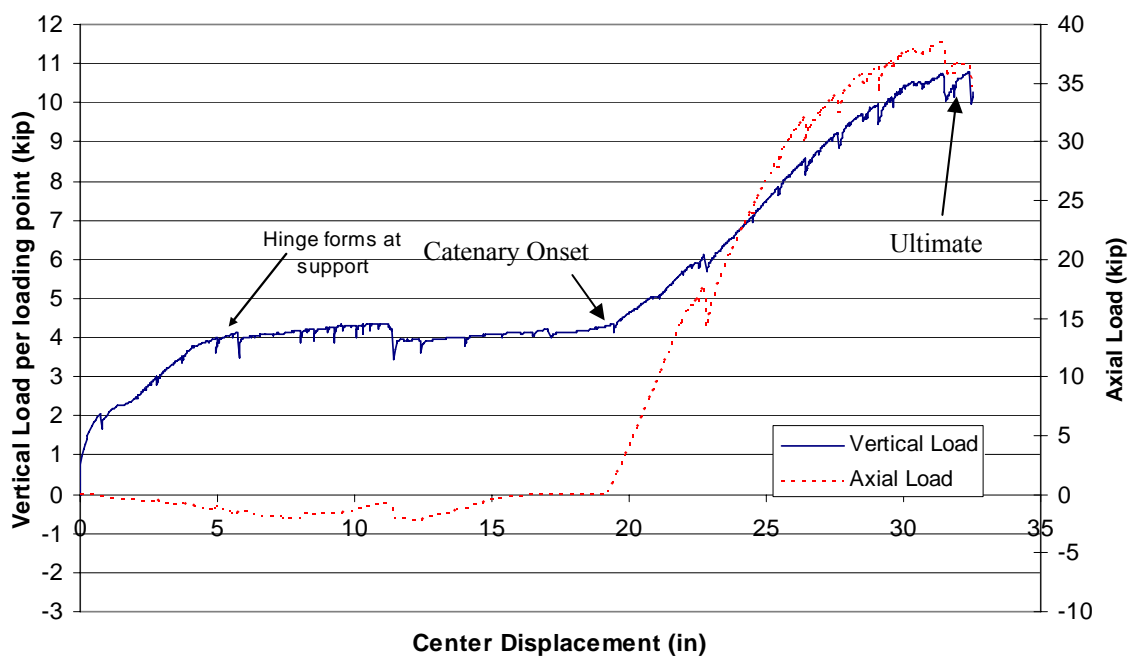
**Figure 5-45** Vertical and Axial loads for NM-2

The specimen preformed almost identically to NM-1 and was able to reach the desired 10.8 k per loading point at 32.3 inches of displacement and 36.6 k axial tension, Figure 5-45. As with specimen NM-1, a wide crack formed at the column stub and hinges formed at the supports at 4 k load per load point. At 36.6 k of axial tension, the CFRP fractured, Figure 5-46 and Figure 5-47.

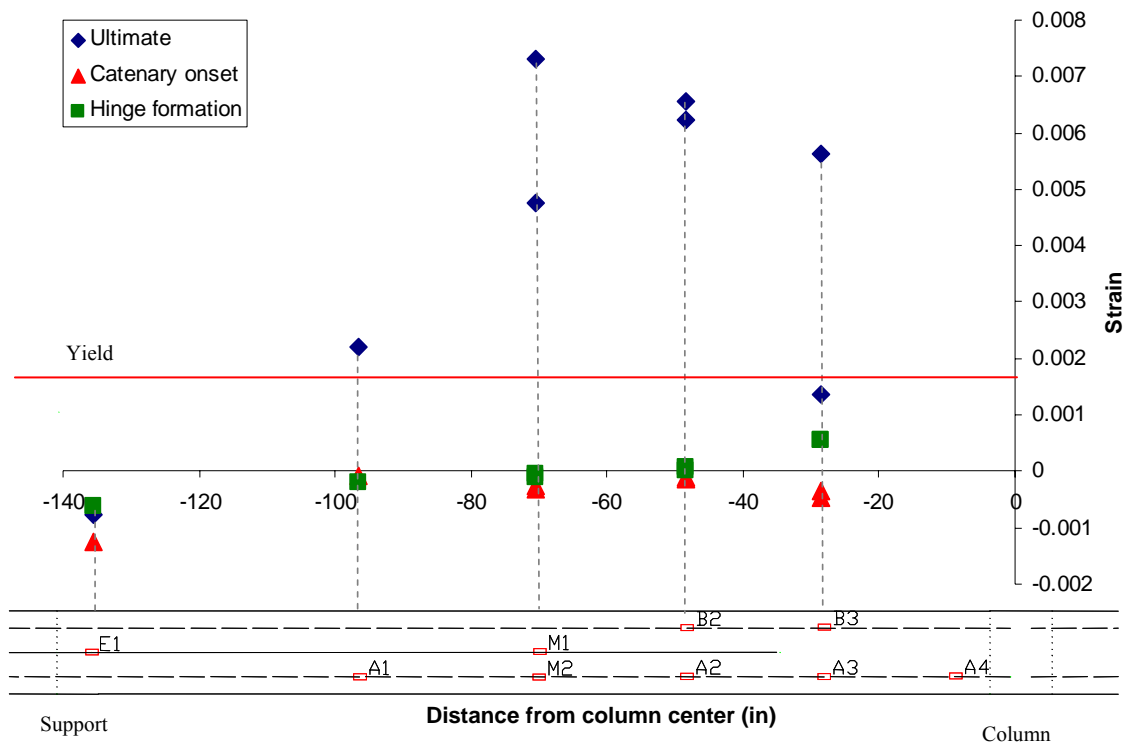
**Figure 5-48** Strains in positive moment reinforcement for NM-2

Strains at the ultimate load and deflection (10.8 k, 32.3 in.) in the positive moment rebar were well above yield through the middle section of the beam, Figure 5-48. At ultimate vertical load, cracks were present throughout the entire depth of the concrete beam. The strains at ultimate in the negative moment reinforcement were also above yield, Figure 5-49. With yielding in the positive and negative moment reinforcement under catenary action, it is not likely the beam will be able to support additional vertical load without substantial deflection. Yielding of the reinforcement may be the reason for the leveling out of the vertical and axial load versus displacement curves near the end of the test.

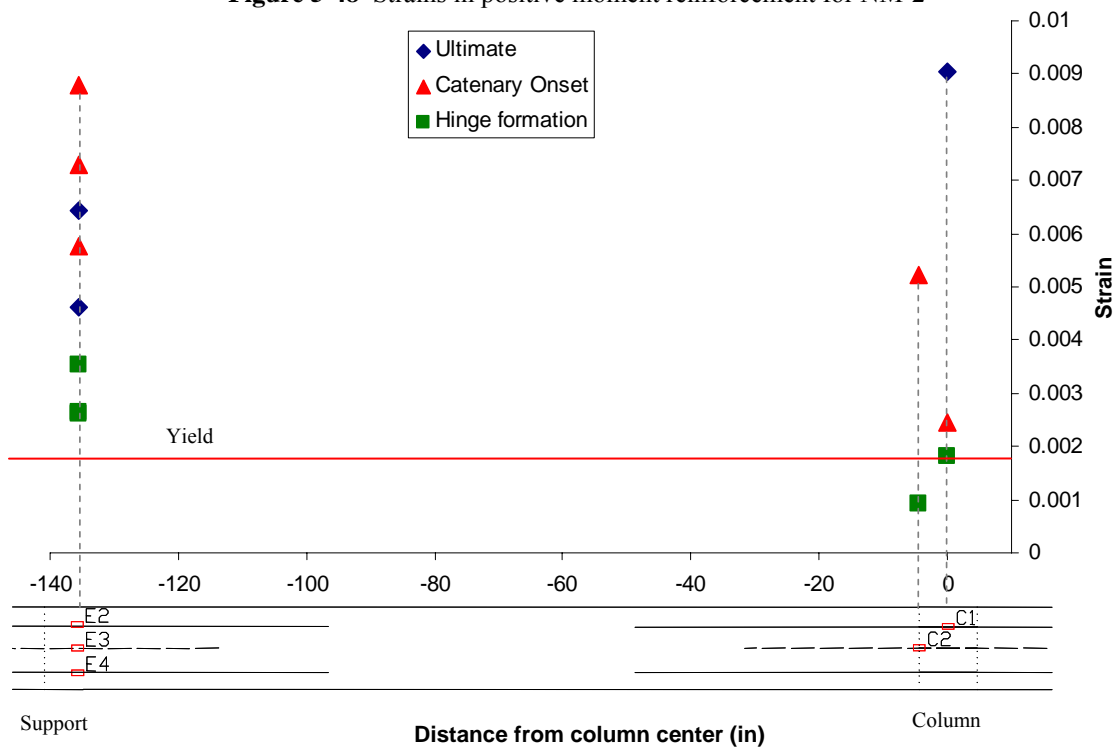
**Figure 5-49** Strains in negative moment reinforcement for NM-2

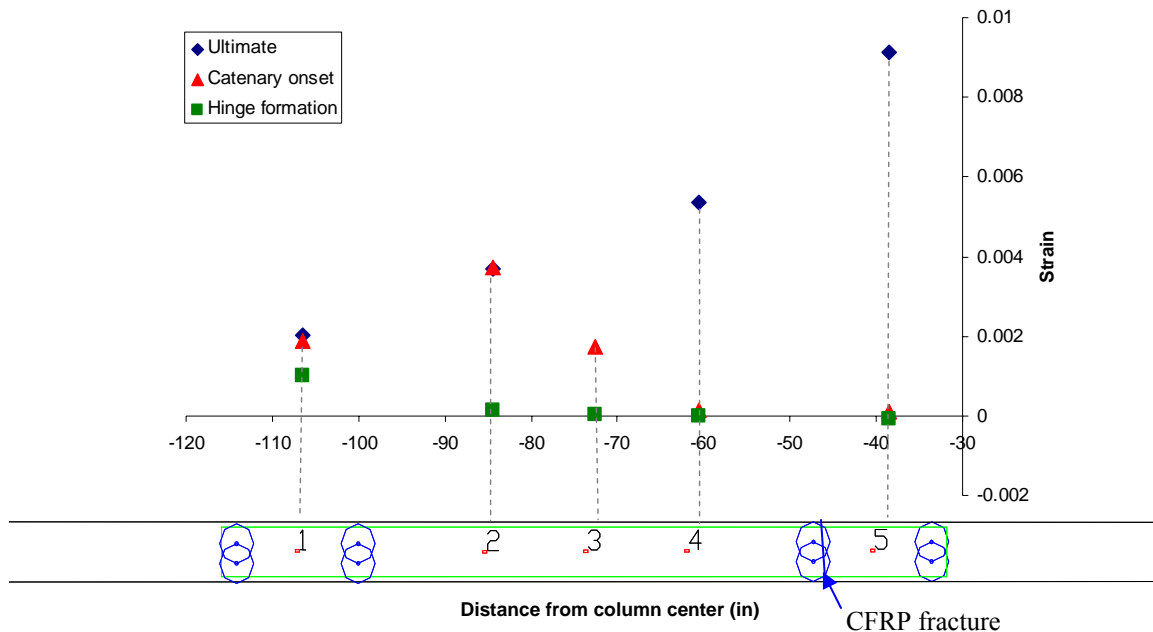
**Figure 5-50** Strains in CFRP for NM-2

The fact that the CFRP fractured just after all the rebar had yielded and the beam was able to reach the desired 10k of vertical load per load point illustrates the efficiency of the amount of CFRP applied. Furthermore, the fact that the CFRP was able to reach at least 90% of its strain capacity confirmed the design detail developed during the anchorage tests.

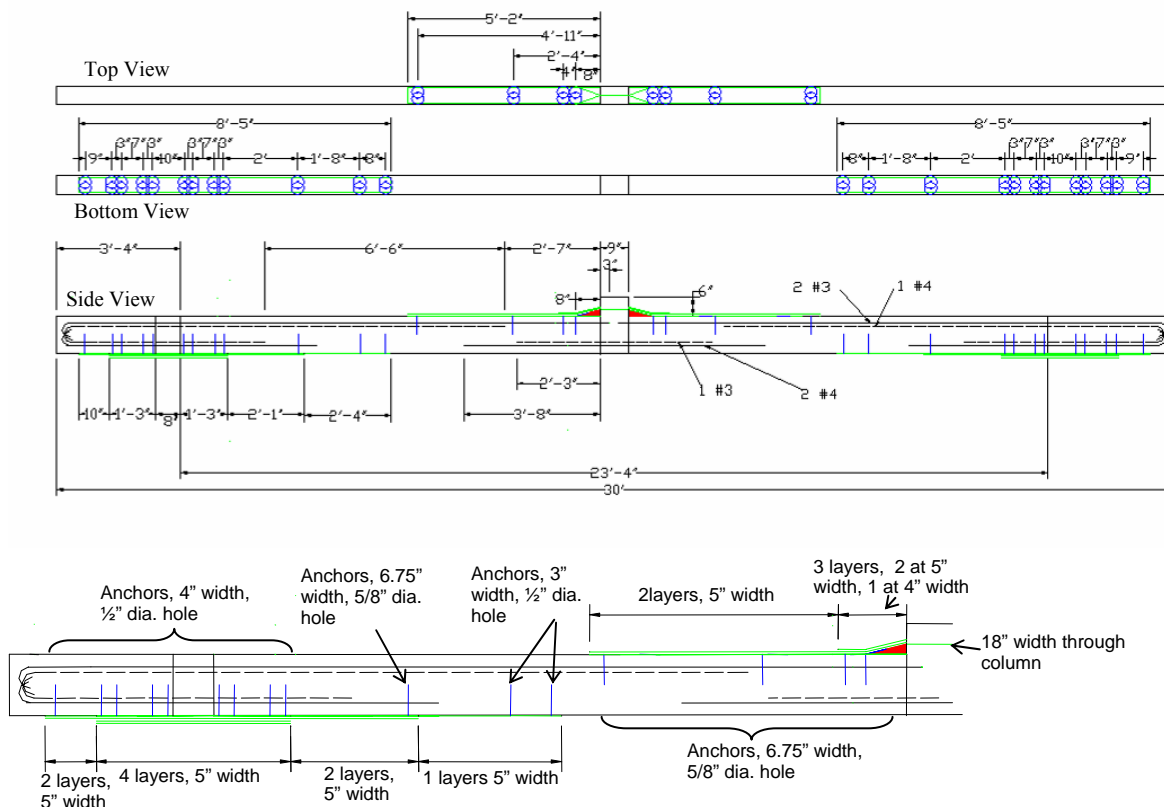
**Figure 5-54** Design of CFRP retrofit for FR-1

The design procedure for the beam is given in Appendix B and the final design is shown in Figure 5-54. The design required numerous layers of CFRP sheets and rows of anchors to nearly double the moment capacity of some sections. The total area of CFRP applied on this beam was  $54 \text{ ft}^2$ , or 4.5 times the amount required for NM-2.

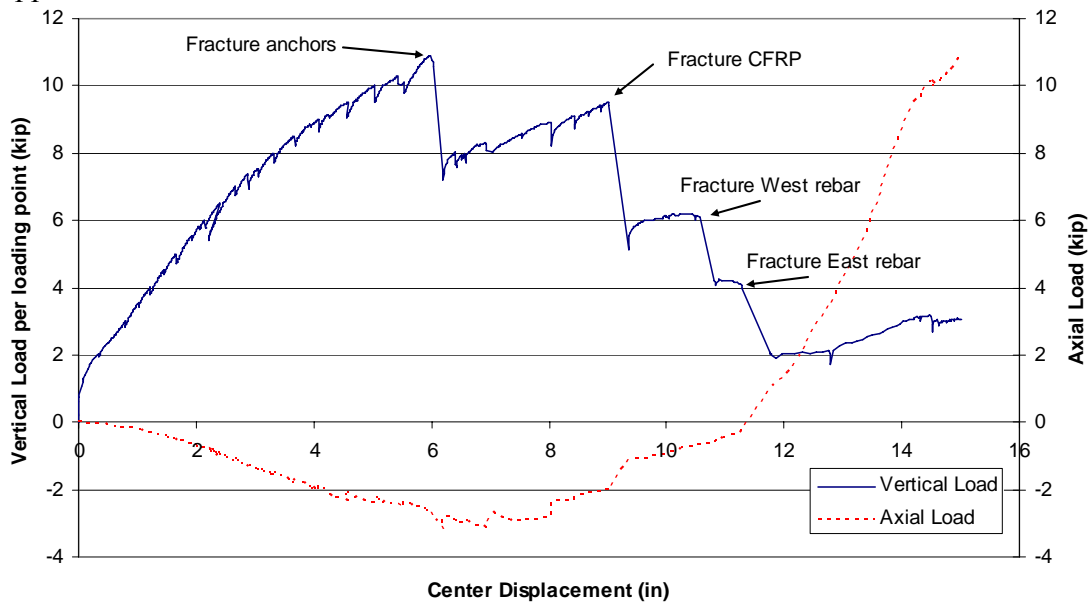
**Figure 5-55** Vertical and axial load versus displacement for FR-1

The specimen was able to reach the desired 10 k per load point at only 6 in. of deflection, Figure 5-55. At this level the anchors at the end of the positive moment CFRP sheet fractured, Figure 5-56. The anchors at this location were designed for a 6 in. wide sheet rather than the 10 in. side sheet that was continued from the previous section. As a result, the anchors fractured rather than the sheet, but they were able to carry the anticipated load (the beam reached 10 k per loading point). After the anchors fractured, the vertical load again increased to 9.4 k at 9 in. of displacement when the negative moment CFRP sheet fractured, Figure 5-57. Although the negative moment CFRP fractured toward the end of the sheet (at the end of the negative moment reinforcement) debonding was present throughout most of the CFRP sheet. Finally at 6 k per load point and 10.6 in. of displacement, the #3 bars (West bar followed by East bar) fractured, Figure 5-58. The specimen developed catenary action and picked up axial tension at about 12 in. of displacement. Due to the unbalanced fracture (failures on only one side of the beam) the rotation of the center column was too great to continue and the test was stopped.

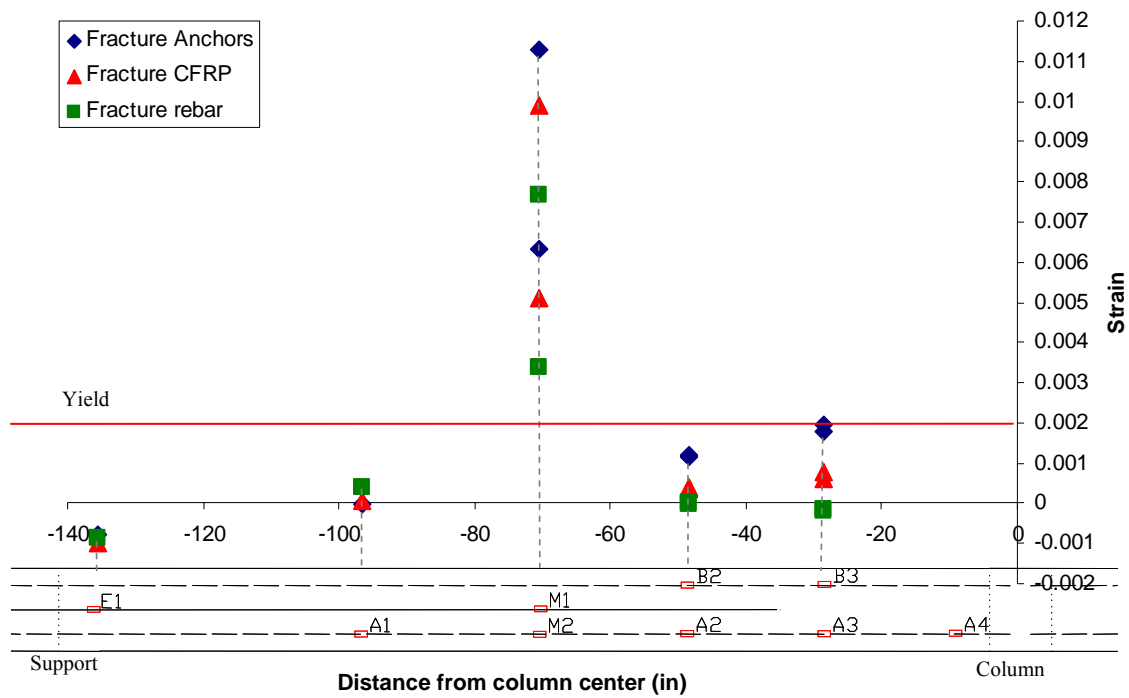
**Figure 5-60** Strains in positive moment reinforcement for FR-1

The strains in the positive and negative moment reinforcement are given in Figure 5-60 and Figure 5-61. The highest strains in the positive moment reinforcement were recorded in gages M1 and M2. CFRP was provided at that location, and the reinforcement had to resist all the bending moment. For the negative moment reinforcement, high strains exist at the support due to the high moment demand (870 k-in) even though 4 layers of 5 in. wide CFRP was provided. At the column, low strains were observed because of the section is under positive moment at that location.

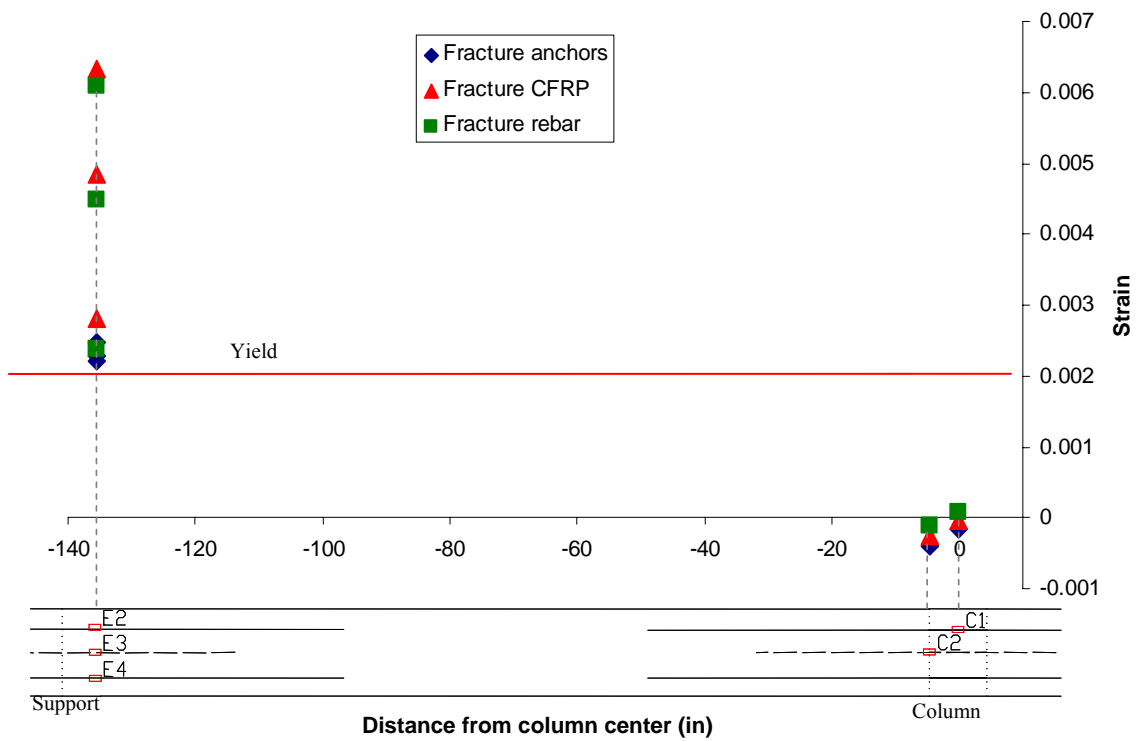
**Figure 5-61** Strains in negative moment reinforcement for FR-1

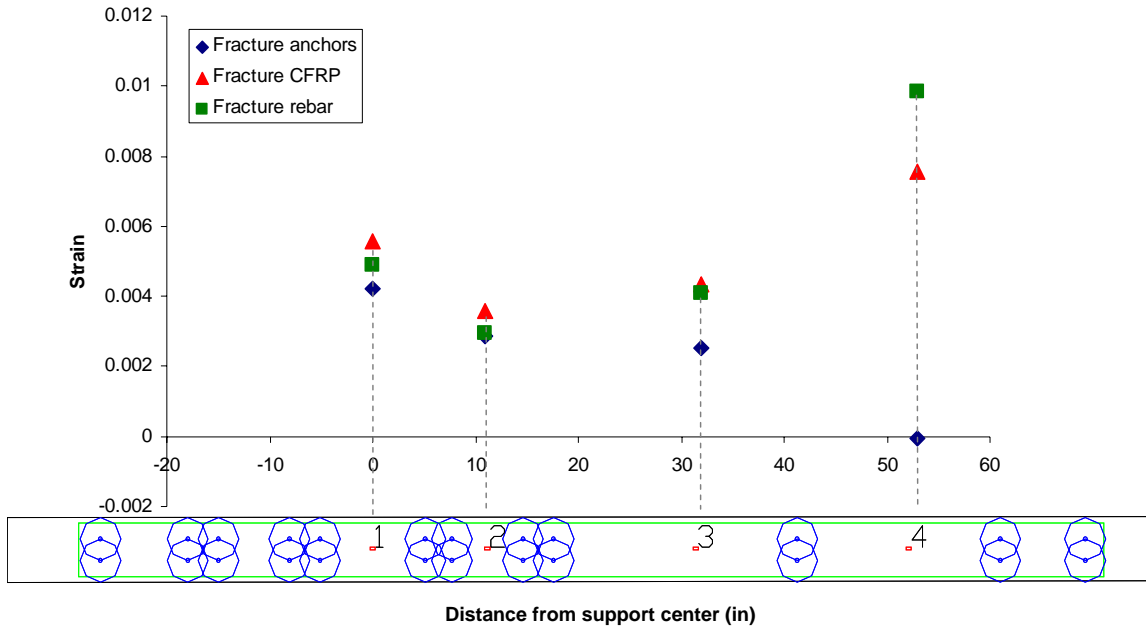
**Figure 5-62** Strains in CFRP over support region for FR-1

The high strains throughout the CFRP indicate how well the design details developed from the anchorage tests worked on this beam. Although numerous layers of CFRP were applied, and moment demands varied throughout the length of the CFRP, the anchors delivered their desired performance and allowed the CFRP to reach much higher strains and tensional forces throughout the retrofit. In fact much of the CFRP along the support and some along the column debonded during the test, but the anchors transferred forces from the CFRP to the concrete and maintained the section's moment capacity.

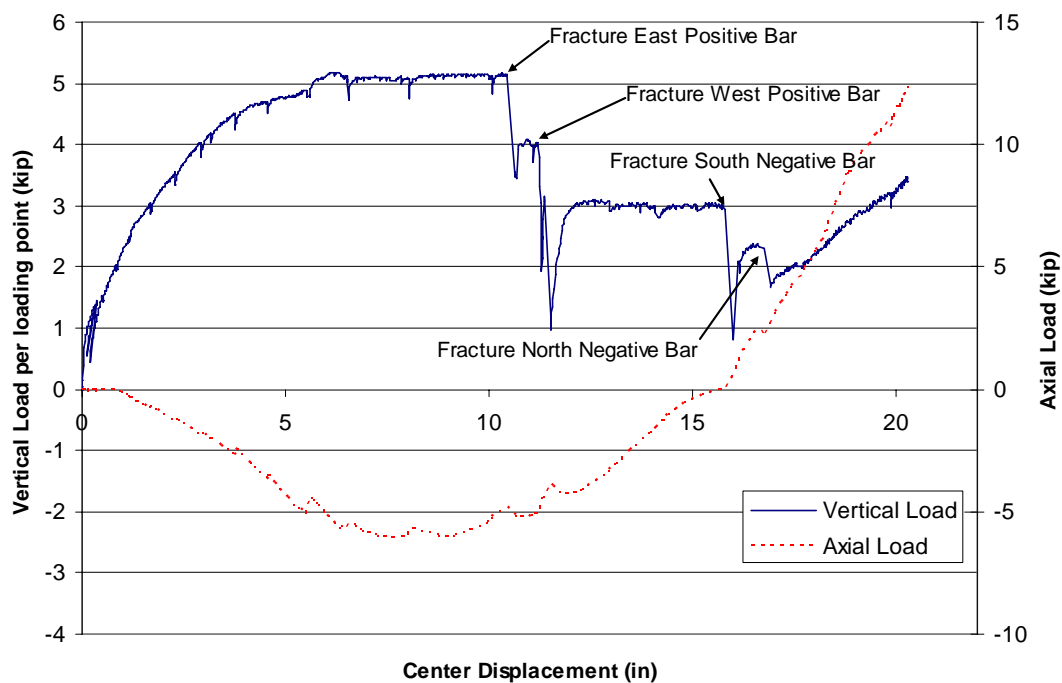
**Figure 5-65** Vertical and axial load versus displacement for CR-1

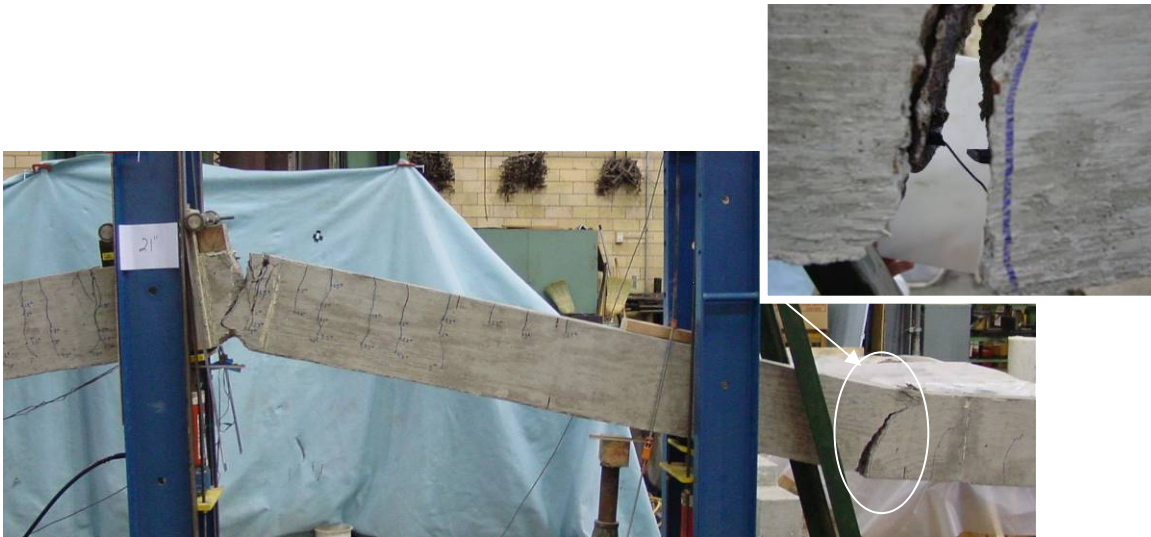
**Figure 5-67** Fracture of negative moment rebar

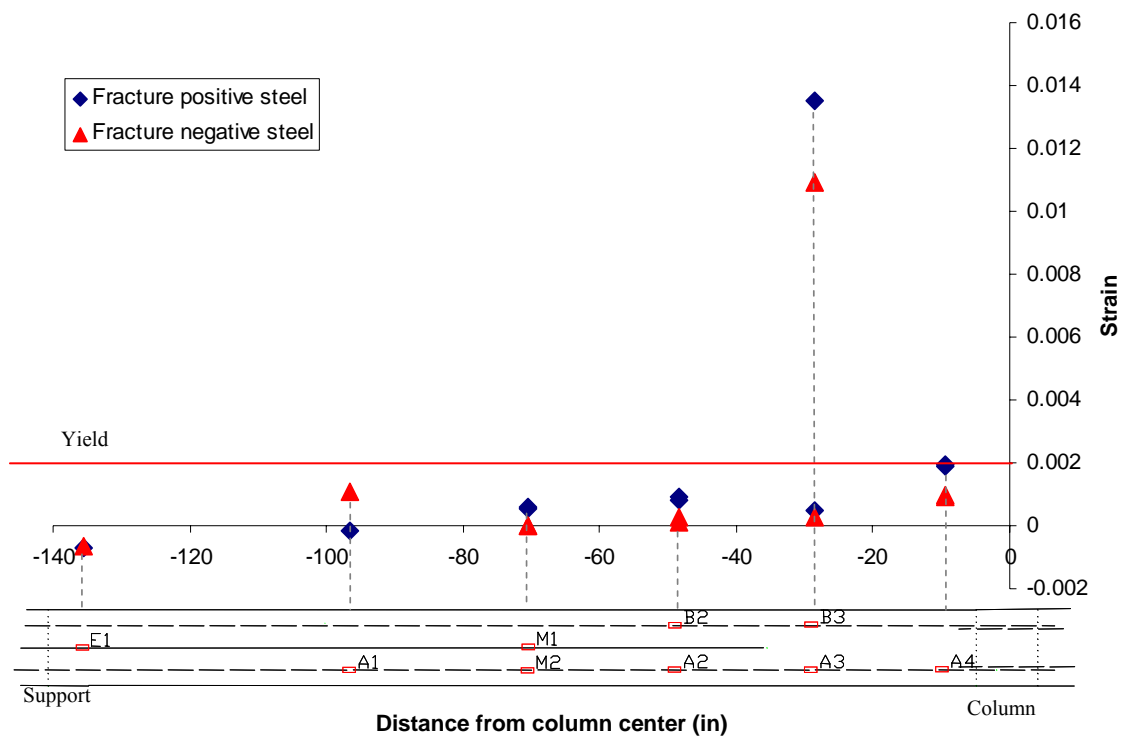
**Figure 5-69** Strains in positive moment reinforcement for CR-1

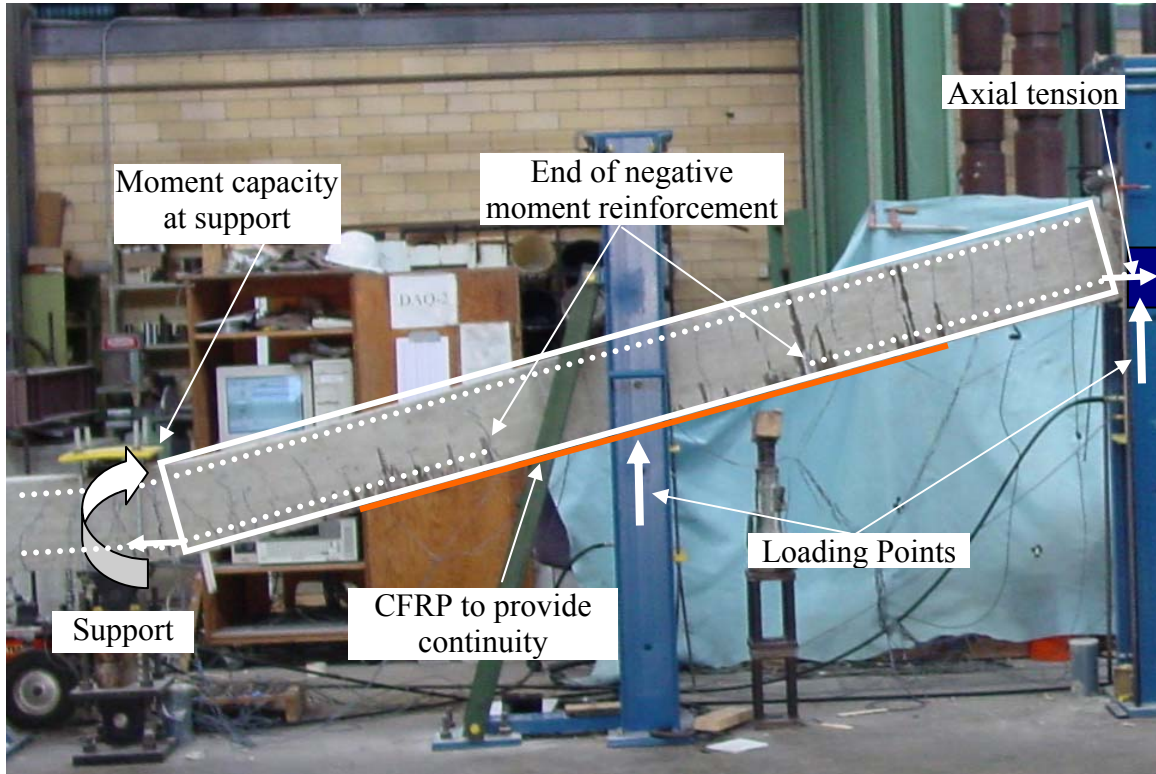
**Figure 6-1** Idealization of specimen NM-2 for case 1

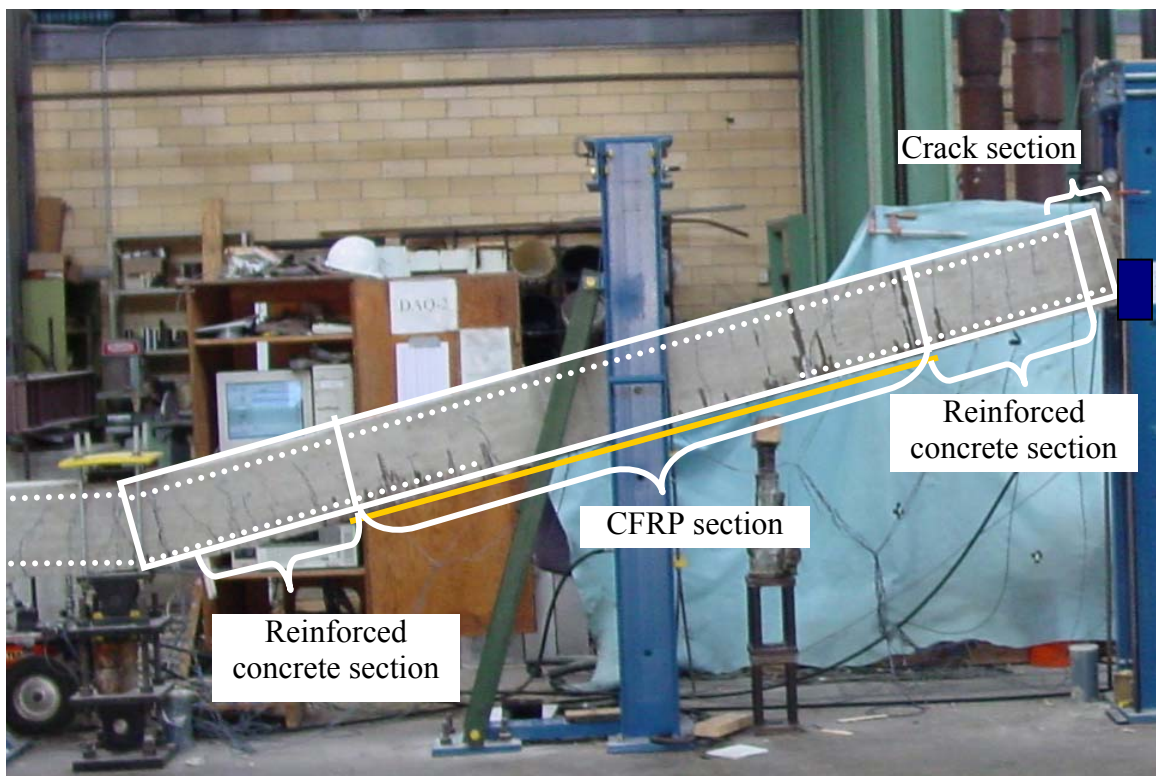
**Figure 6-8** Division of beam for elongation analysis

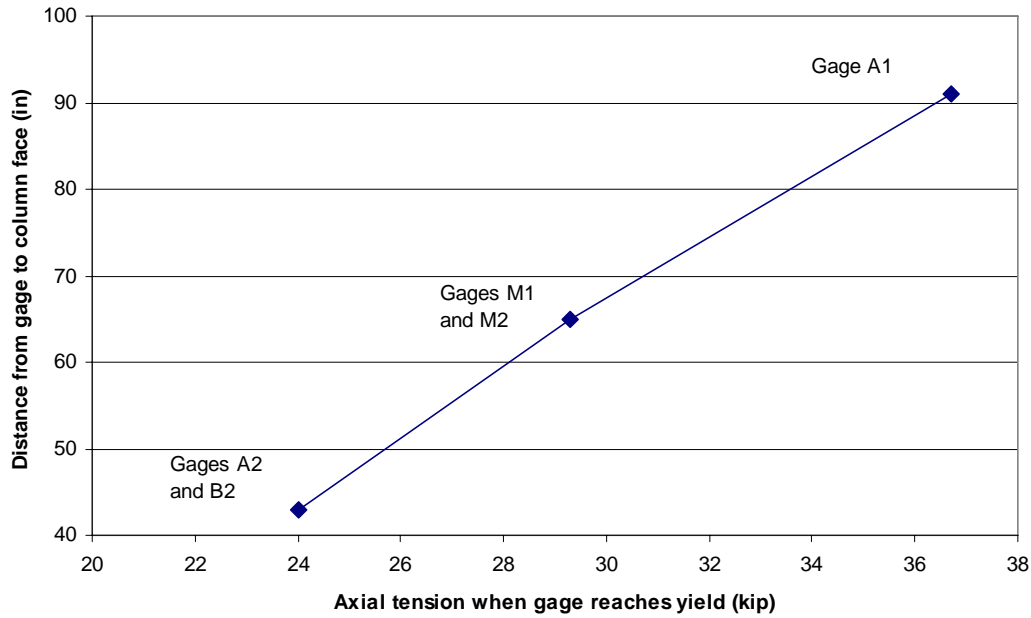
**Figure 6-10** Variation of yielding along beam (NM-2)

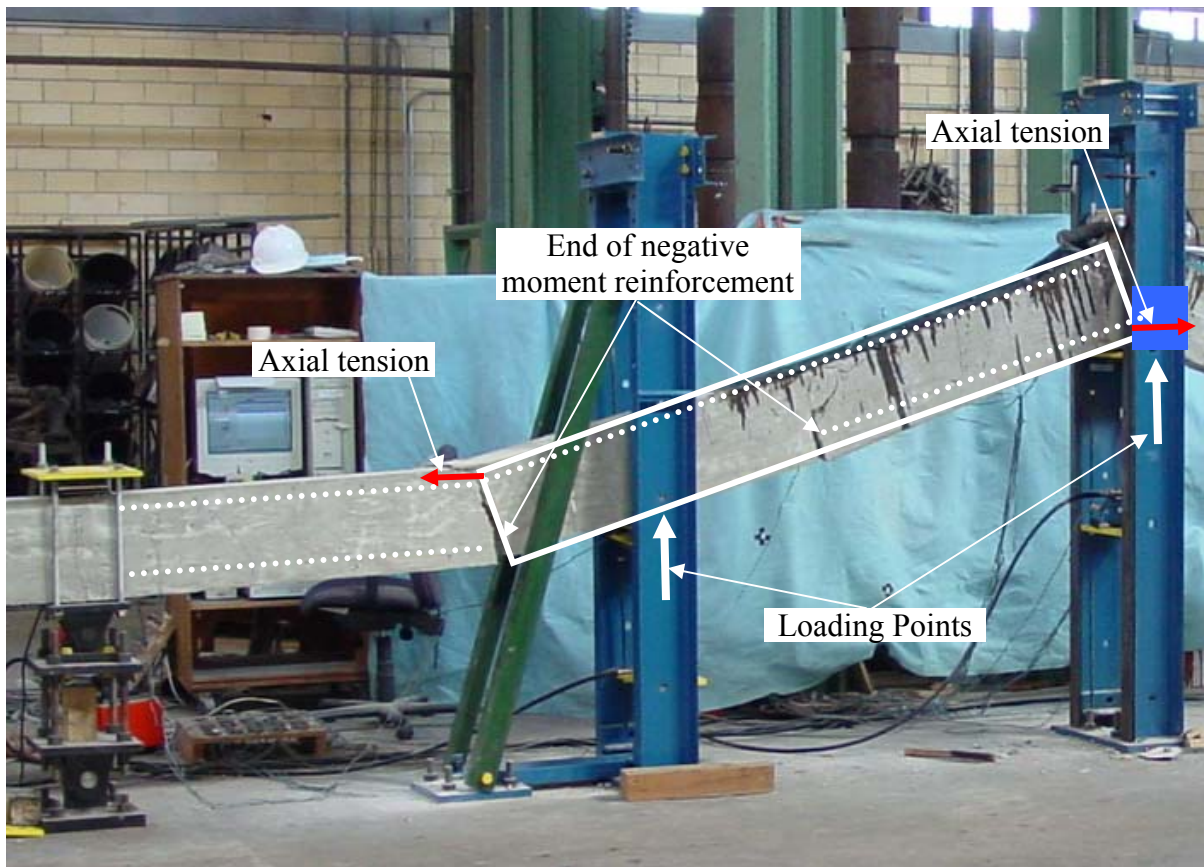
**Figure 6-12** Idealization for case 2

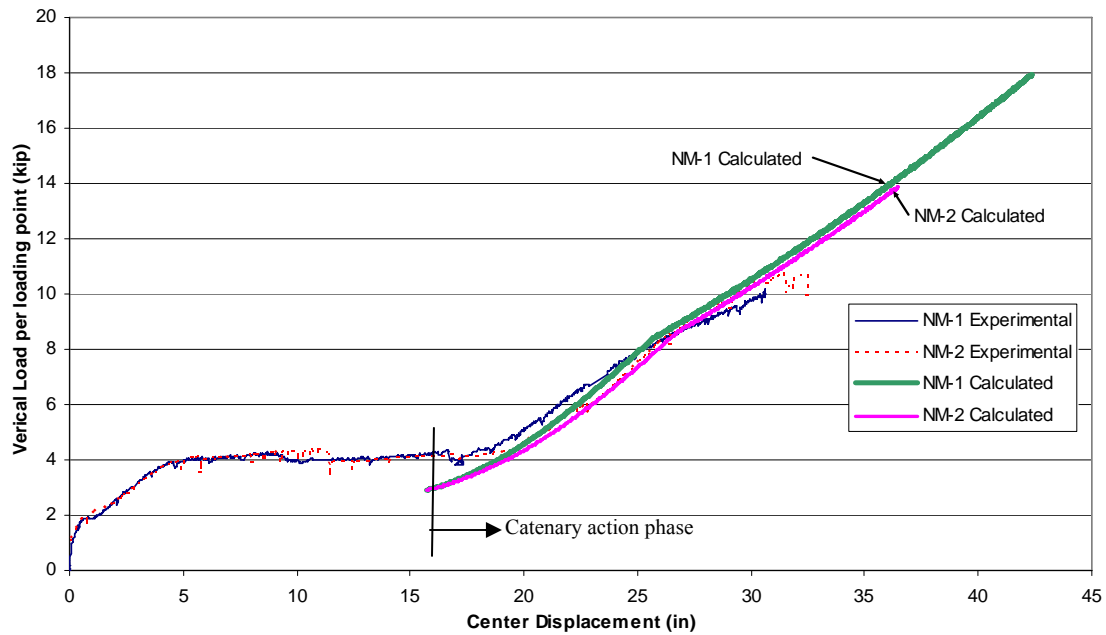
**Figure 6-15** Vertical load versus deflection for specimens NM-1 and NM-2 and analysis model

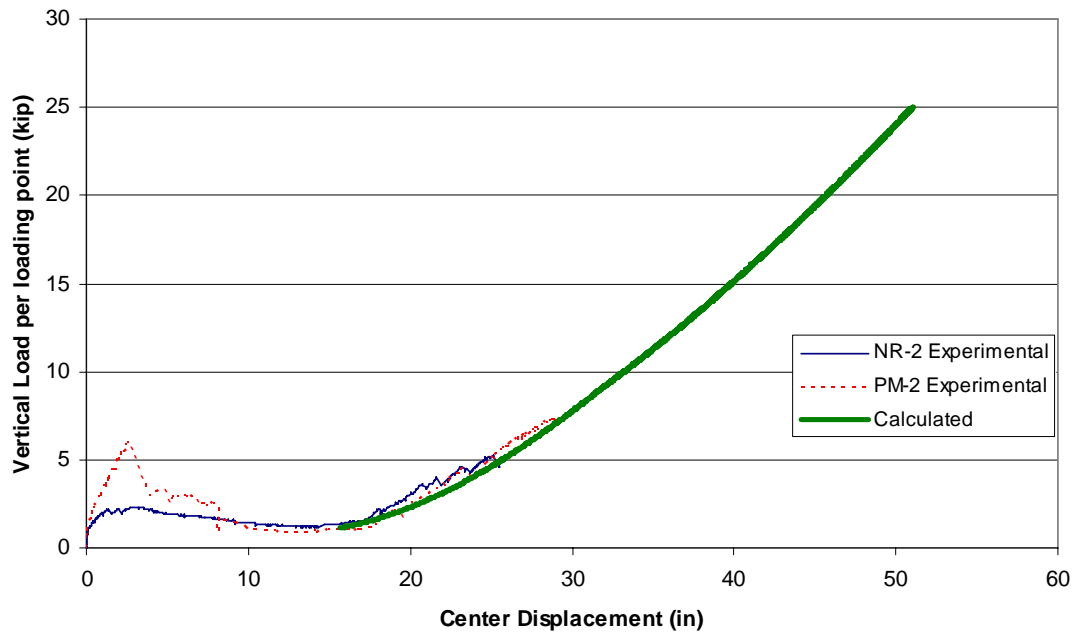
**Figure 6-17** Vertical load vs. displacement curves for spec NR-2 and PM-2 and analysis model

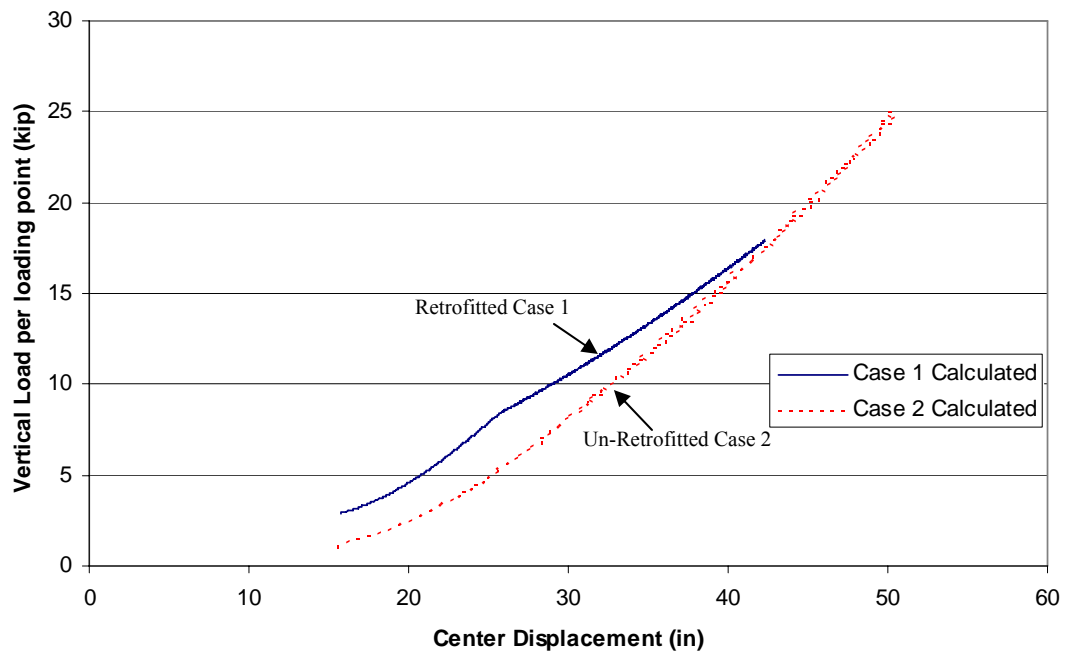
**Figure 6-19** Comparison of case 1 and case 2 vertical load vs displacement

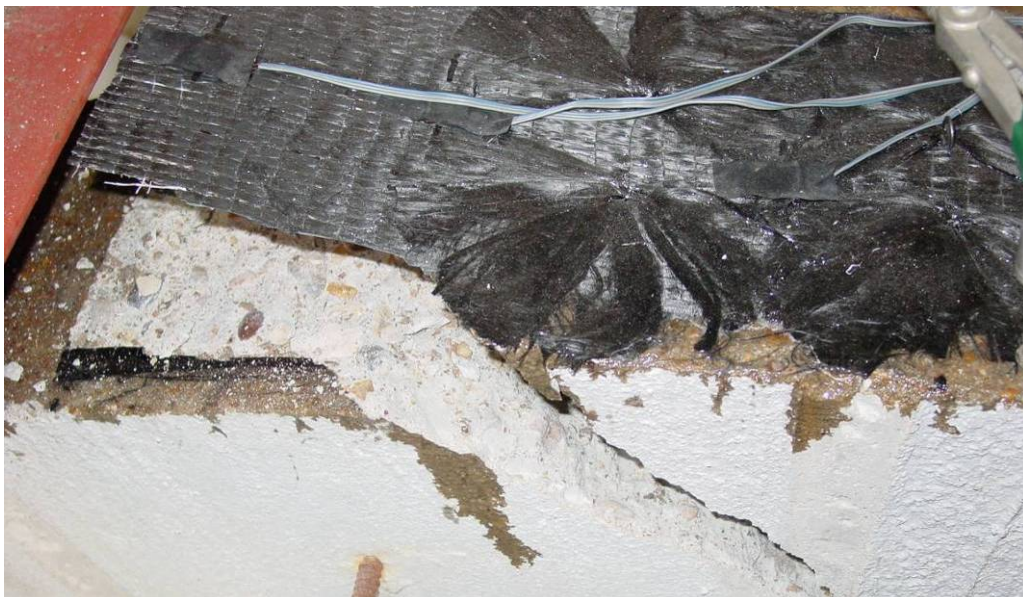
After Testing: Failure by shear in concrete block

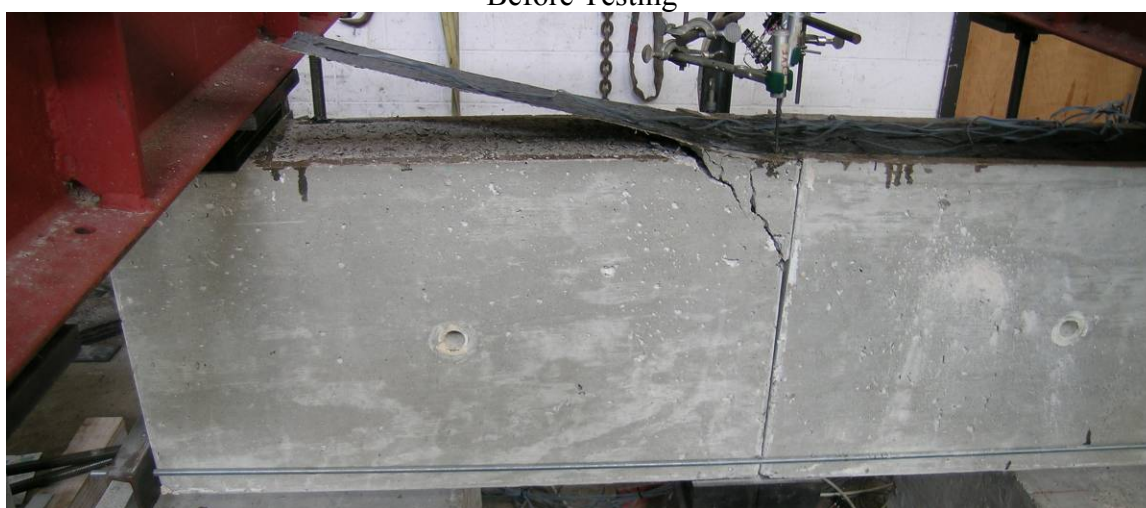
After Testing: Failure by corner crack and debonding

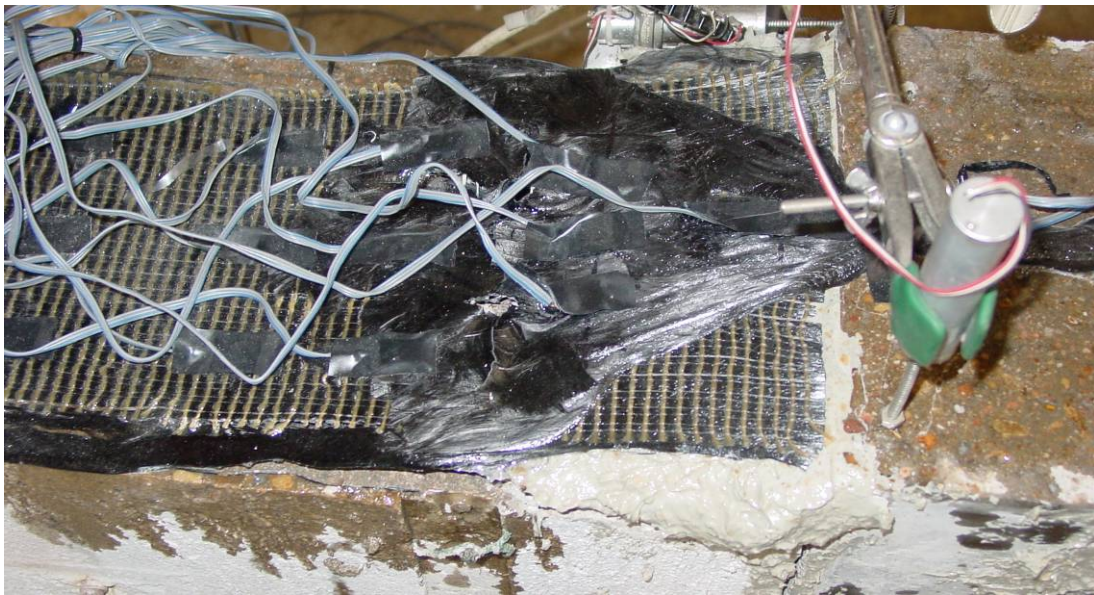
After Testing: Failure by anchor fracture

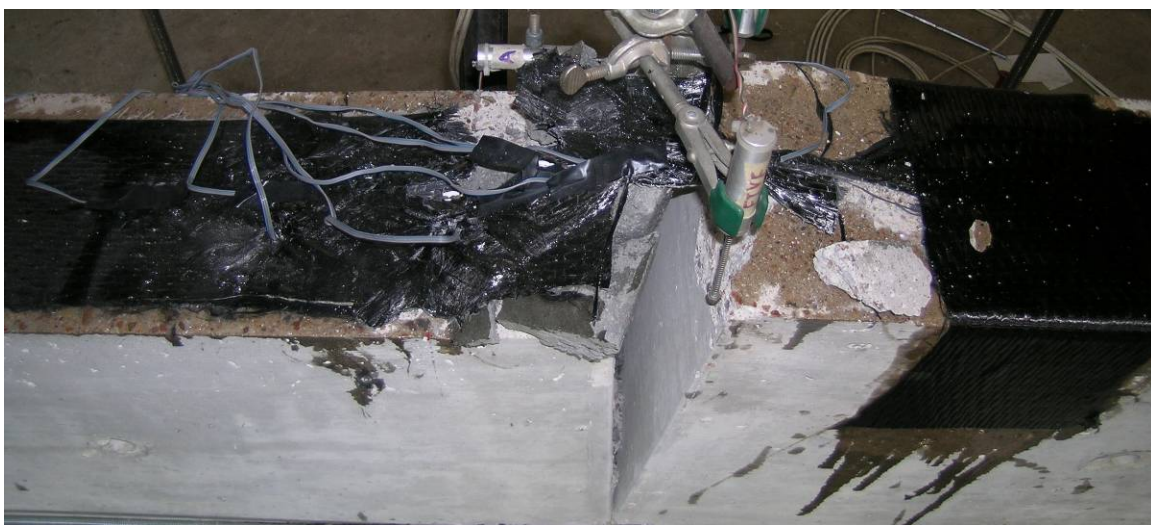
After Testing: Failure by FRP Fracture

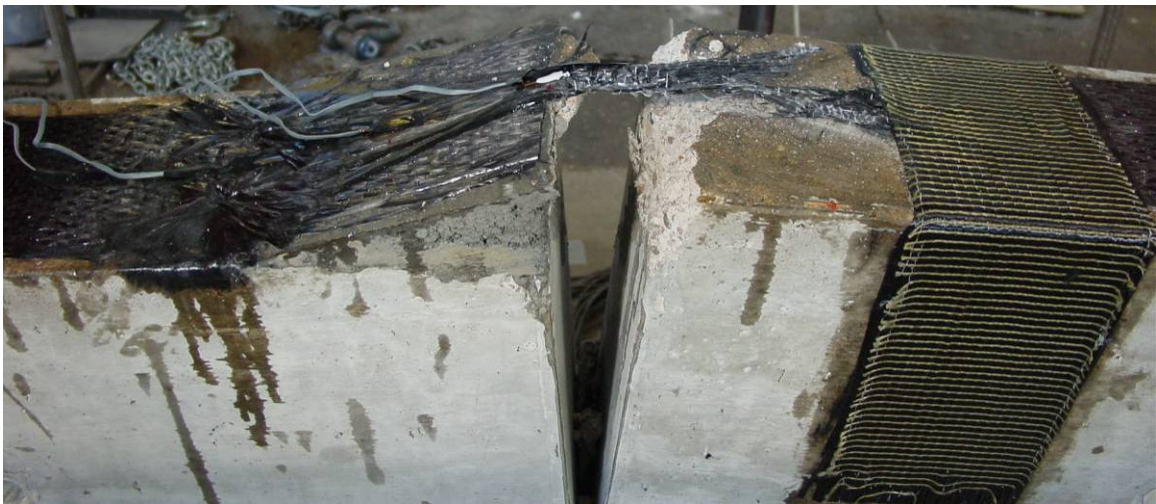
After Testing: Failure by premature fracture in column part

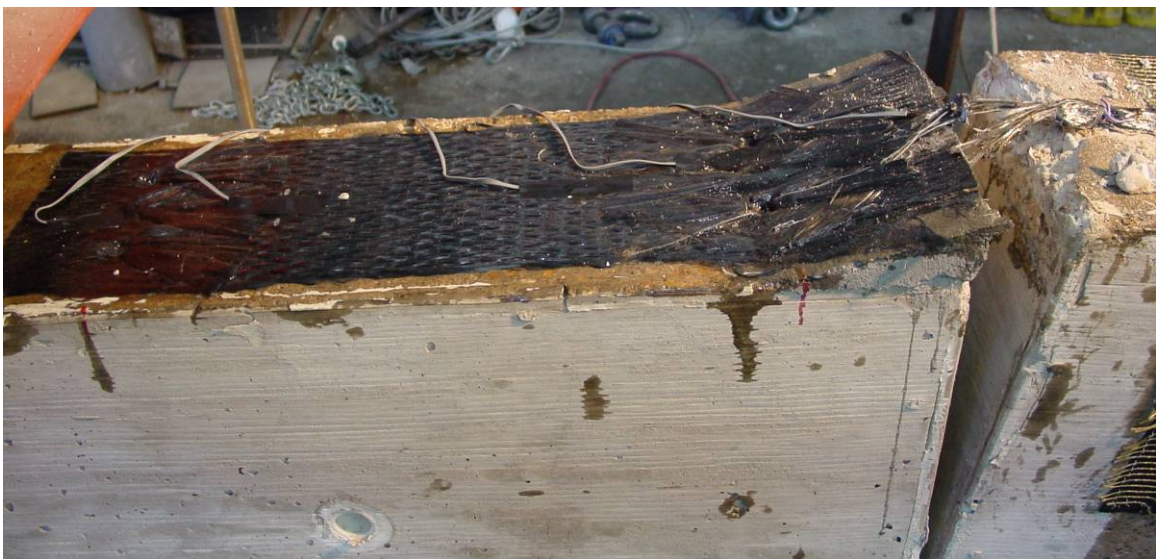
After Testing: Failure by FRP fracture
